Counties (MD/PA) Cecil/Chester

## A COMPARATIVE ASSESSMENT OF THE STATUS AND CONDITION OF THE MONUMENTS ON THE MASON AND DIXON LINE.

DATE OF OBSERVATION: 27 APR 89

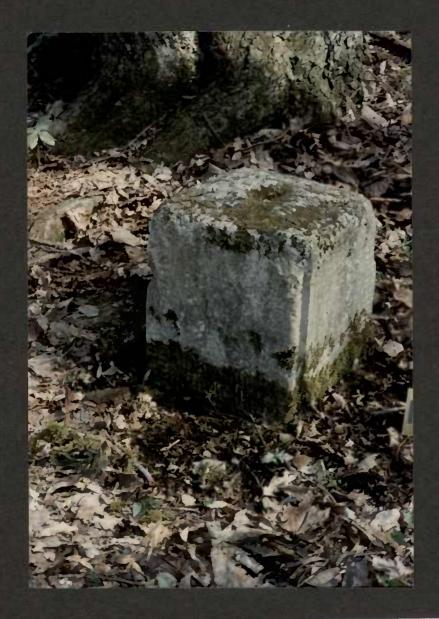
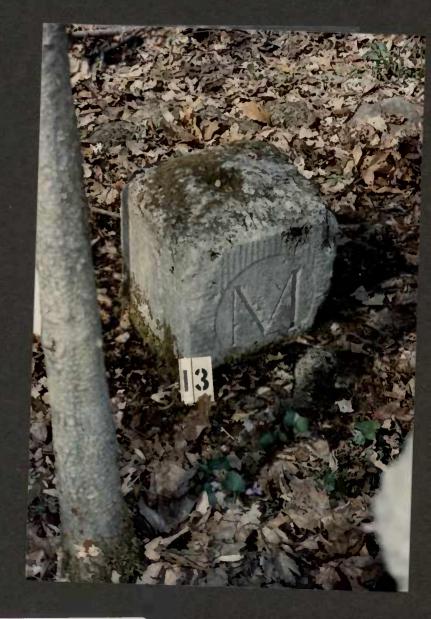
13(14) 27 APR 89

12" square by 11" to 13" out of ground. "M" and circle panel are very good with much fluting showing on "M" side. "P" is just readable, no circle panel, and little fluting. Vert. and hor. edges good w/chips; cup in top, E&W fluting well worn, Large chip on STATUS: PROTECTED ENDANGERED MISSING UNEXPOSED NOT FOUND bottom SE edge

Original M&D milestone of 1766 in place, in good condi-Current status and condition: tion, firmly set; letters, circle panel, & fluting clear; all corners and edges chipped; large pit in

apex of top. Protected by site. Although this monument shows little sign of abuse, it

is showing considerable weathering from when last inspected and, additionally, it is loose in the ground. It is now classed as endangered and deteriorated since it is also in close proximity to new housing and a business. We did not dig, so the condition of the foundation is uncertain. Note from the 1900-03 resurvey that the stone had been broken previously and had been repaired.

Status: Endangered Condition: Deteriorated Foundation: Stone is loose.

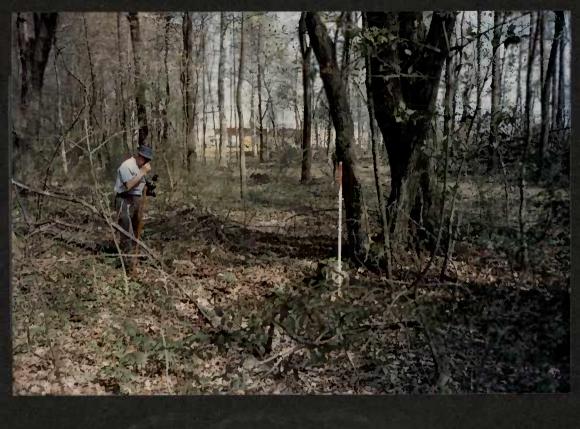
13(14) 27 APR 89 View NW at #13. Area is being cleared. Exposed stone is in good condition.
